NASA Contractor Report 3189

Hygrothermal Damage Mechanisms in Graphite-Epoxy Composites

Frank W. Crossman, R. Ernest Mauri,
and W. John Warren

CONTRACT NAS2-9563
DECEMBER 1979

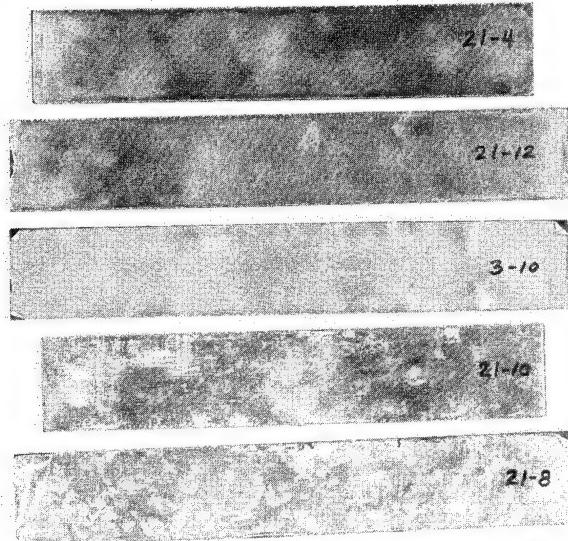
Equilibrium moisture content of the clad specimens was generally higher than the unclad (0₄, 90₄)_T laminates (see Figures 6-7). The higher moisture content of the clad laminates can probably be attributed to a preferential collection of moisture in the blistered regions. The random distribution of blisters over the surface of the specimens suggests that they are caused by

Figure 4. Appearance of clad T300/5208 and T300/5209 (Spec. 3-10 only) after exposure to 55% RH and 95% RH (Spec. 21-8 only) at 93°C. Note edge delamination of 3-10 and blistering of 21-10 and 21-8.

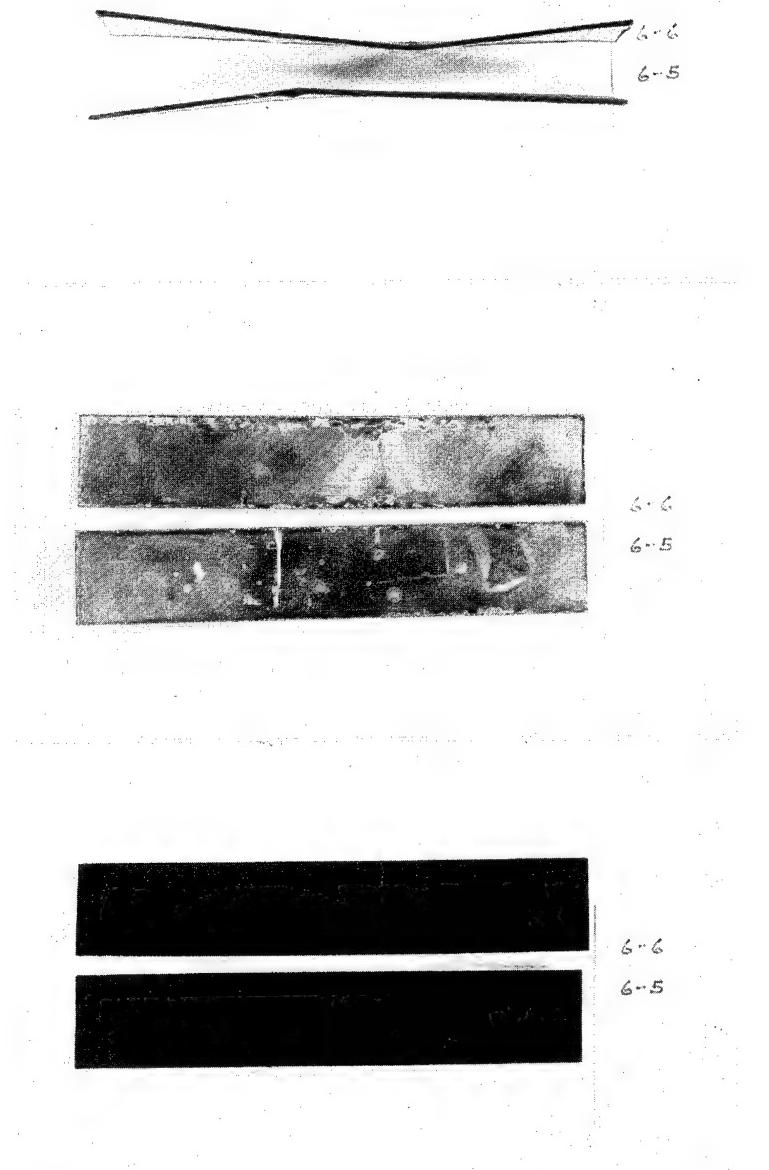
Figure 8. Appearance of $(0/90)_{2s}$ clad T300/5209 laminates equilibrated at 93°C/55% RH and then desorbed under flexure at 70°C.

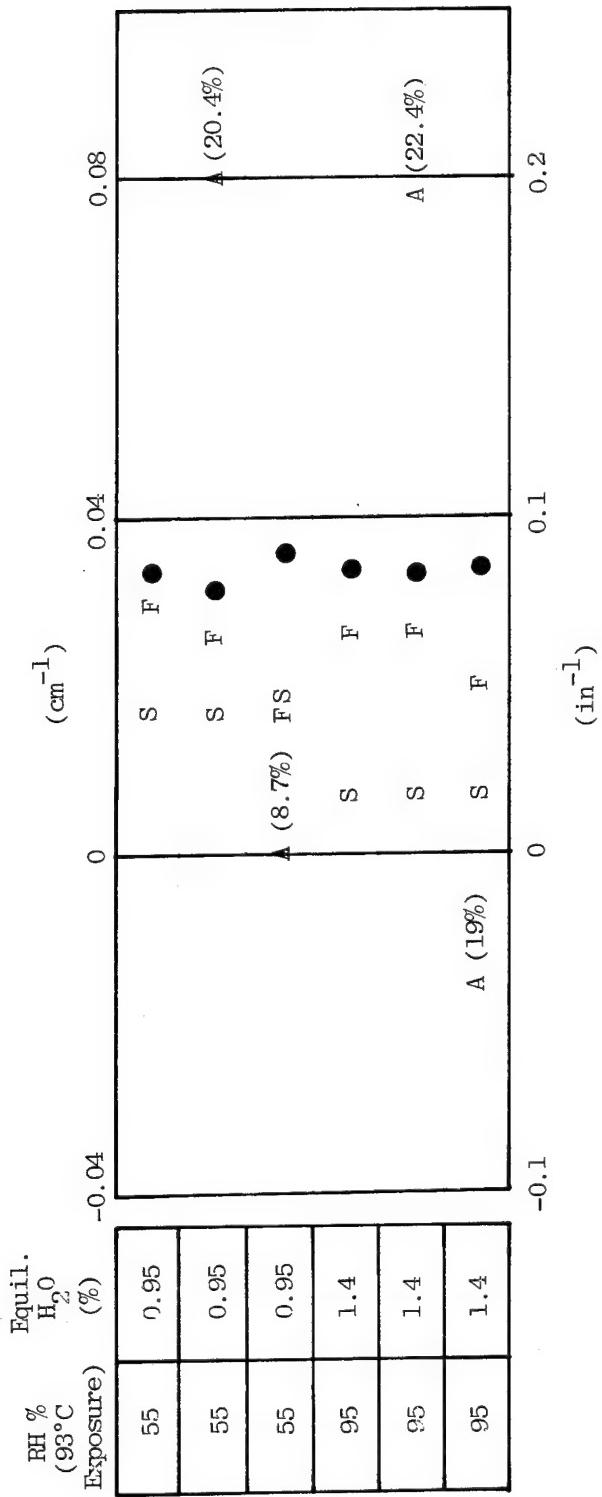
Figure 9. 25°C Curvature of T300/5208 (0₄, 90₄)_T Laminates Exposed to Different Hygrothermal and Mechanical Histories.

The specimens in Figure 8 demonstrate that although the desorption kinetics are insensitive to applied flexural stress up to 25 percent of ultimate, the internal stress state or specimen dimensions can be significantly altered. Figures 9 and 10 show the original as cured, dry curvature of a series of $(0_4, 90_4)_T$ laminates and the final curvature after exposure to humidity at 93°C until equilibrium was reached and then drying at 70°C . The curvature in the specimens containing equilibrium moisture content (denoted by the symbol S) and the curvatures applied during drying at 70°C (denoted with the symbol A) are also given. Two out of three specimens in each series were flexed to place the 90° layers in either tension (low or negative curvature in the figure) or compression.

The T300/5208 laminates show about a 15-25 percent reduction in curvature in the final dry state in specimens subjected to positive or zero applied curvature. Specimens which were flexed to place the 90° layers in tension show a reduced curvature in the dry condition of 40-55 percent.

Alteration in the final curvature due to application of stress during desorption can be caused by either microcracking or by stress relaxation. If stress relaxation is the dominant mechanism, then it will tend to shift the final curvature toward the applied value. This shift should be noticed for both positive and negative applied curvatures, as is found for the T300/5209 laminates in Figure 10. Lack of shifting in T300/5208 under positive curvature suggests that the predominant mechanism for alteration of internal stresses in this material is microcracking, while in T300/5209, it is viscoelastic relaxation. Note in Figure 10 that the final curvature of T300/5209 specimens which absorbed water at 93°C and were desorbed at 70°C under no applied stress is higher than the initial dry curvature. This increase in

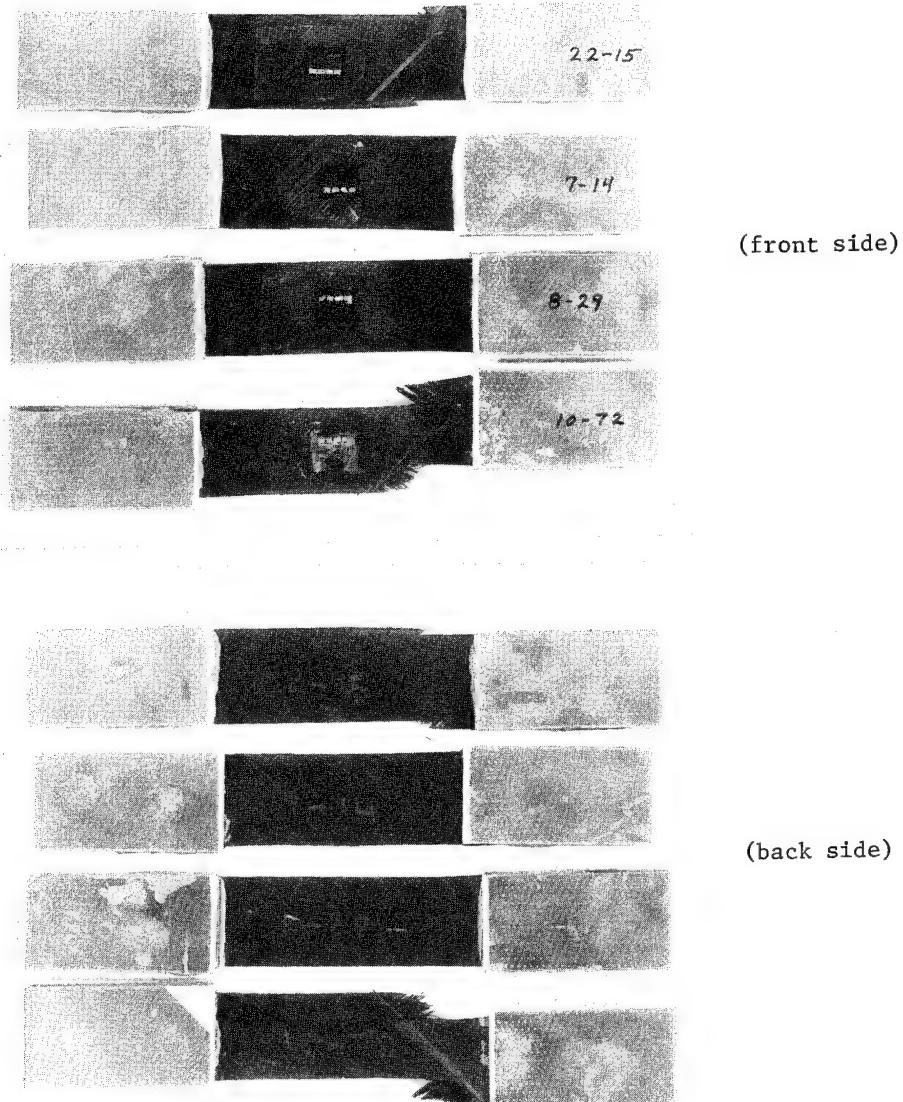
The specimens were tabbed with aluminum sheet stock and a 0°, 90° strain gage was applied to one side of the specimen with Eastman 910 adhesive as shown in Figure 14. The figure illustrates the typical failure modes found in this test. Specimen 22-5 (T300/5208) shows a separation into two pieces and failed in a brittle manner in room temperature testing. T300/5209 specimen 7-14 shows a pattern of surface cracks parallel to the fibers but did not fail by separation. In elevated temperature testing of T300/5209 the specimens deformed in a ductile manner showing a necking down (Spec. 8-29) prior to separation due to large applied strains (Spec. 10-72). Data for all specimens tested is tabulated in Appendix B, Table 3, which provides values for the Young's modulus E_x , the Poisson ratio, ν_{xy} , the inplane shear modulus $G_{12} = E_x / (2(1+\nu_{xy}))$, and the shear strength $\tau_{12} = \sigma_x / 2$. The shear strength of the majority of T300/5209 specimens

Appearance of $(\pm 45_2)_S$ laminates after tensile testing.
(a) 22-15 is T300/5208 equilibrated at 70°C/95% RH, and tested at 25°C.
(b) 7-14 is T300/5209, equilibrated at 70°C/95% RH, and tested at 25°C.
(c) 8-29 is T300/5209, dry, tested at 70°C. Note necking.
(d) 10-72 is T300/5209, dry, cycled 100 times to 93°C, and tested at 93°C.

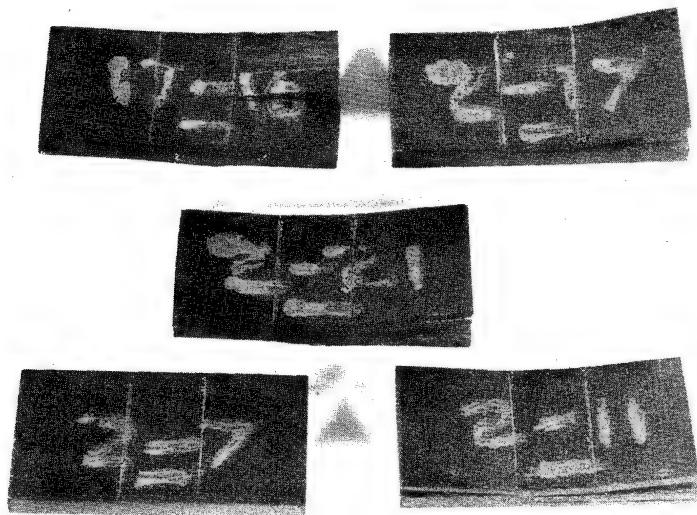
Figure 26(b). Typical Shear Failures in the Four-Point Bending ($S = L/3$) Fixture. See Table B4 for Specimen Hygrothermal History.

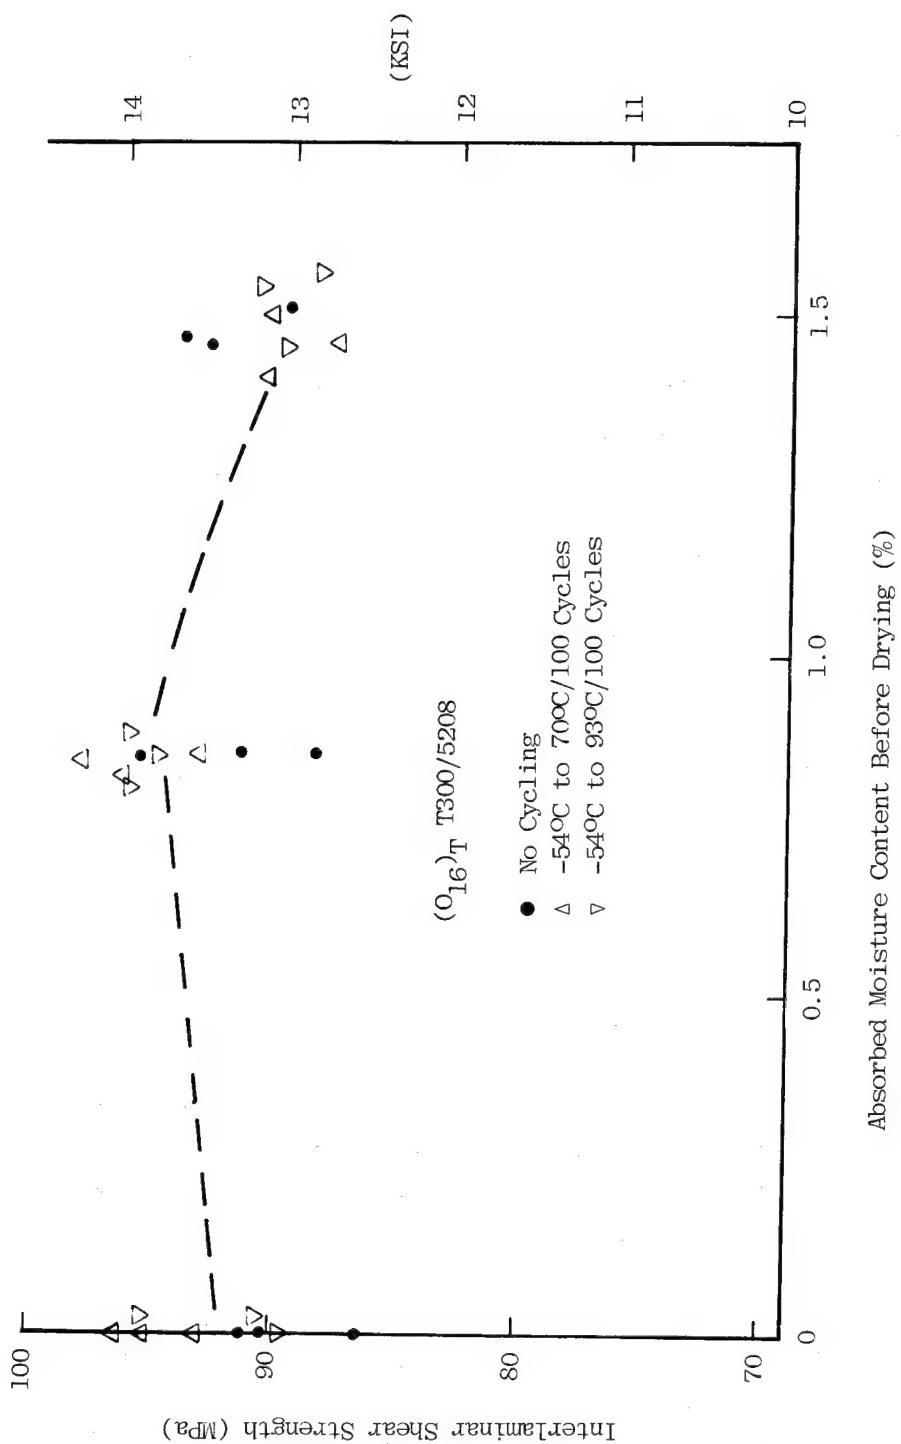
Figure 27. Interlaminar Shear Strength of T300/5208 vs. Equilibrium Moisture Absorbed Prior to Cycling, Drying and Testing.

where P is the peak load, b the specimen width, and h the specimen thickness. Figures 27 and 28 plot the interlaminar shear strength (ILS) of T300/5209 and T300/5208 as a function of the equilibrium water content absorbed by each specimen at 93°C prior to hygrothermal cycling, drying, and testing. Specimens were hygrothermally cycled 100 times over the temperature range indicated, as described in Chapter 2.

In the T300/5208 series no statistically significant change in ILS can be observed as a function of prior moisture content or hygrothermal cycling. The T300/5209 series shows a significant loss of ILS after exposure to humid-

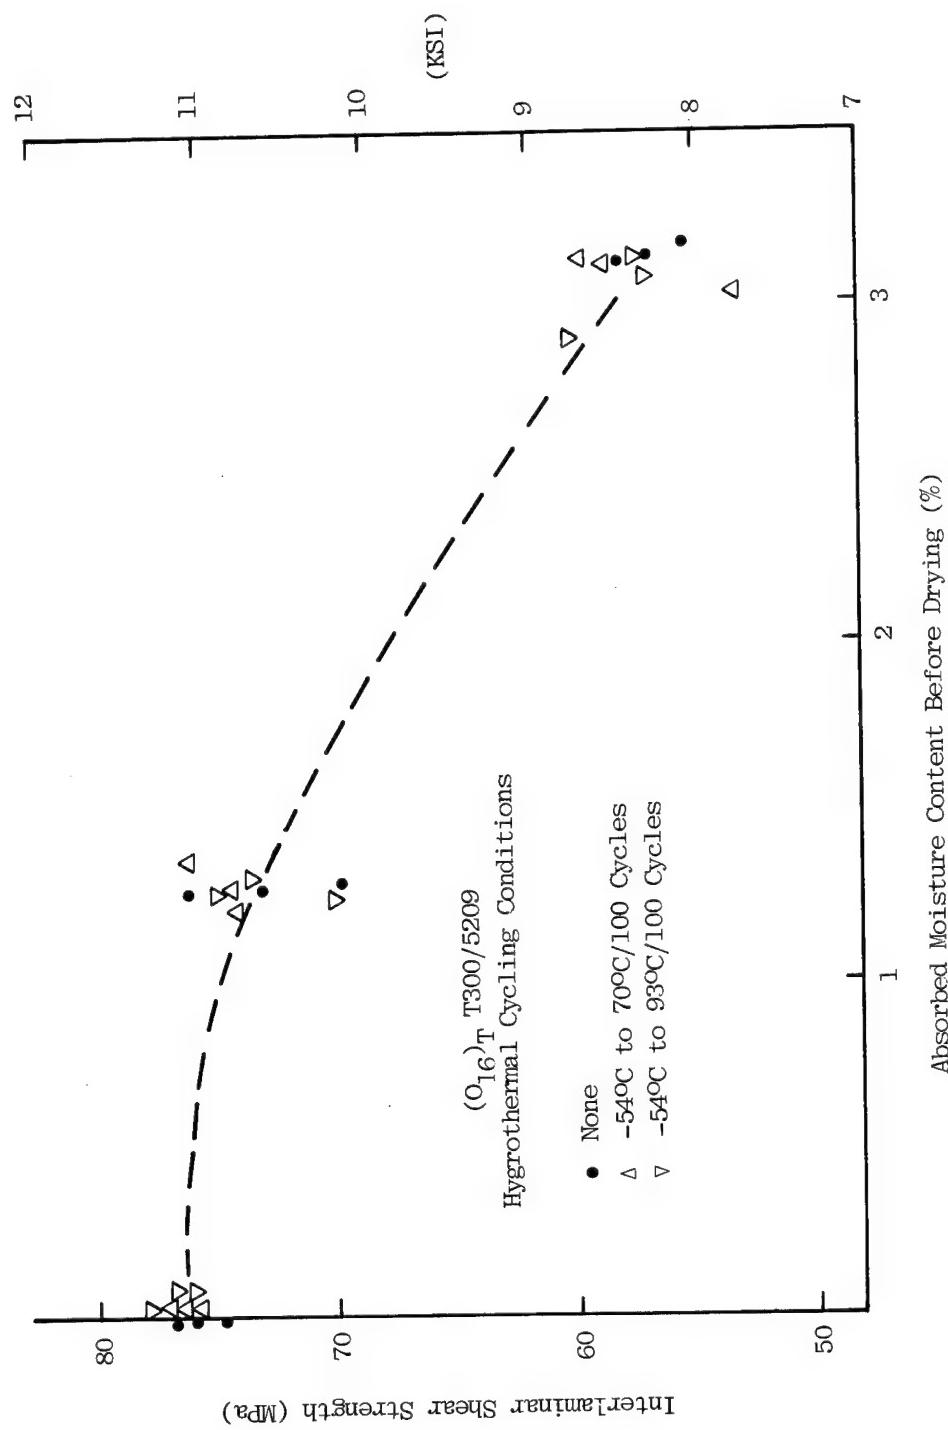
Figure 28. Interlaminar Shear Strength of T300/5209 vs. Equilibrium Moisture Absorbed Prior to Cycling, Drying and Testing.

ity at 93°C. However, the loss of strength appears to be independent of hygrothermal cycling. The large reduction in ILS for T300/5209 specimens which absorbed 3 percent moisture may be contributed to by the extreme loss of inplane shear stiffness and strength noted in this system at 93°C after exposure to 95% RH at 70°C (see Figures 22 and 23). The interlaminar shear specimens exposed to 95% RH at 93°C have been subjected to temperature greater than the wet glass transition temperature of this material. The lack of ILS loss in T300/5209 exposed to lower humidity and in all T300/5208 tests indicates the importance of not exceeding the wet glass transition temperature during accelerated moisture conditioning at elevated temperatures.

In T300/5209, accelerated moisture conditioning at temperatures near or above the wet glass transition temperature appears to cause a permanent loss of inplane shear strength (Figure 23) as well as interlaminar shear strength which accompanies those reversible losses due to moisture-induced plasticization. On the other hand, the lack of these effects in T300/5208 tests suggests that moisture conditioning at temperatures as high as 93°C can be used with this system in an accelerated test program.

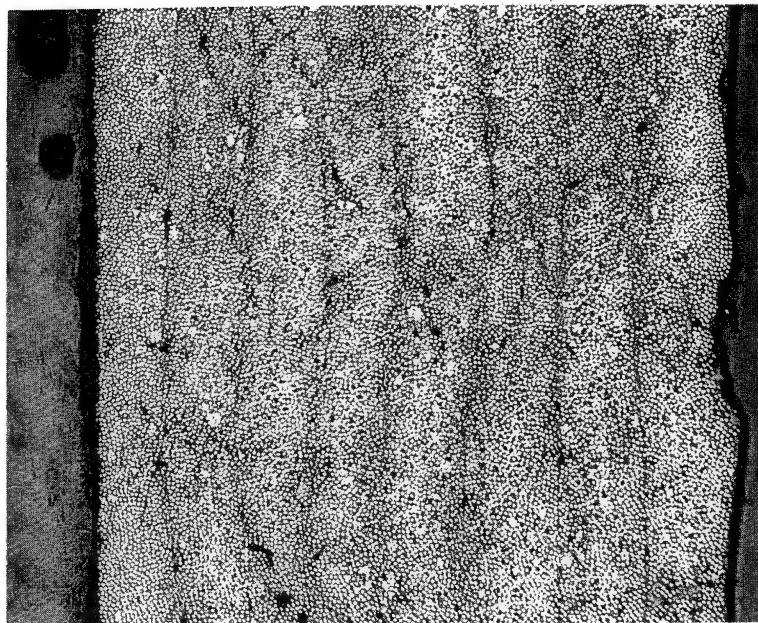
Figure 30.

Figures 30 and 31 show low and high power micrographs of dry UD and quasi-isotropic T300/5209 laminates cycled to a maximum temperature of 93°C. The microstructures, Figures 30a and 31a, are indistinguishable from micrographs of the original as fabricated panels shown in Appendix A. All 5209 laminates contain rounded matrix voids with dimensions on the order of 10-30 μm . There is little evidence that these rounded voids act as microcrack initiation sites during hygrothermal cycling.

(a) Plate D2826, 100X, $(Og)_T$. T300/5209, Spec. 1-4, dry, $-54^{\circ}C$ to $93^{\circ}C/100$ cycles.

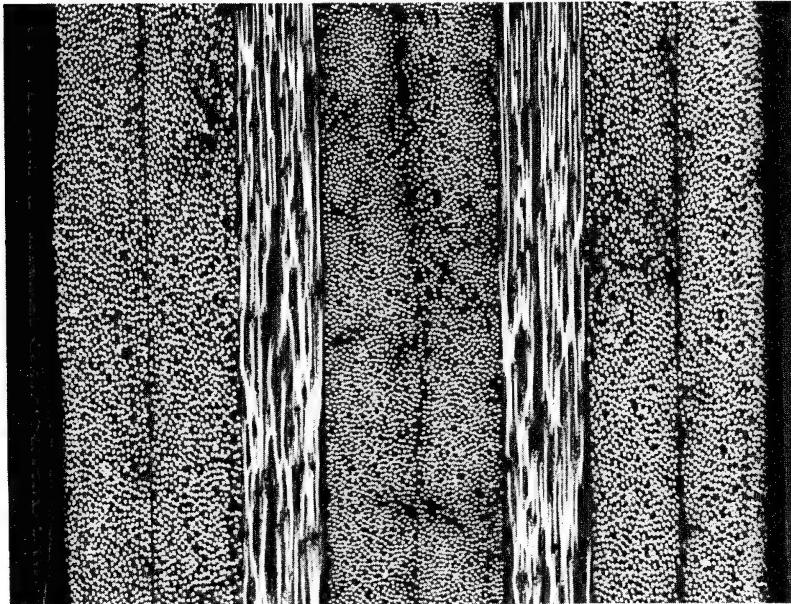
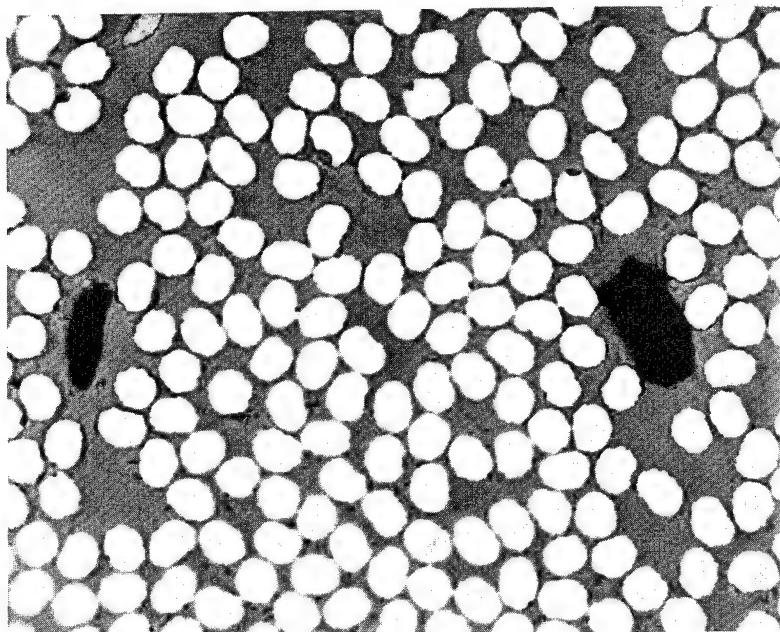
Figure 31.

(a) Plate D2829, 100X, $(+45/-45/0/90)_s$ T300/5209, Spec. 12-4, dry,
-54°C to 93°C/100 cycles.

(b) Plate D2831, 1000X, Spec 12-4.

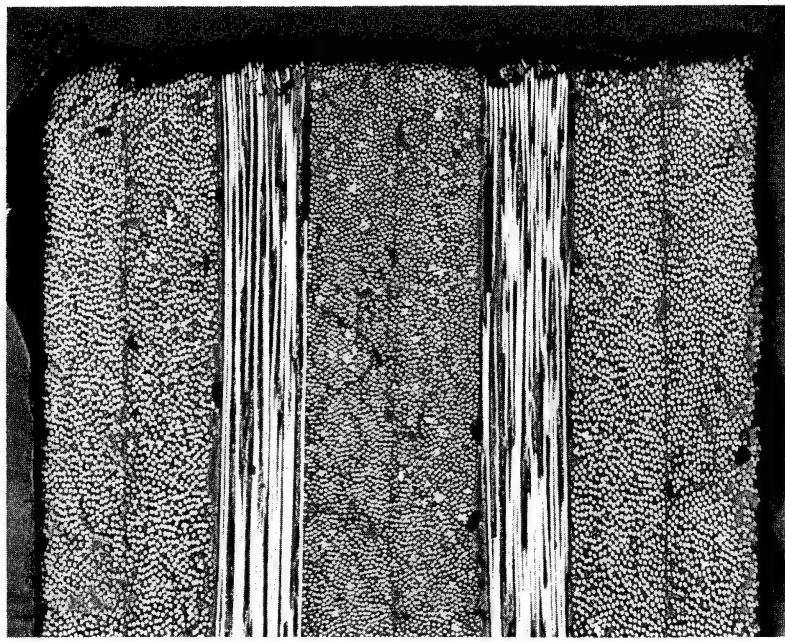
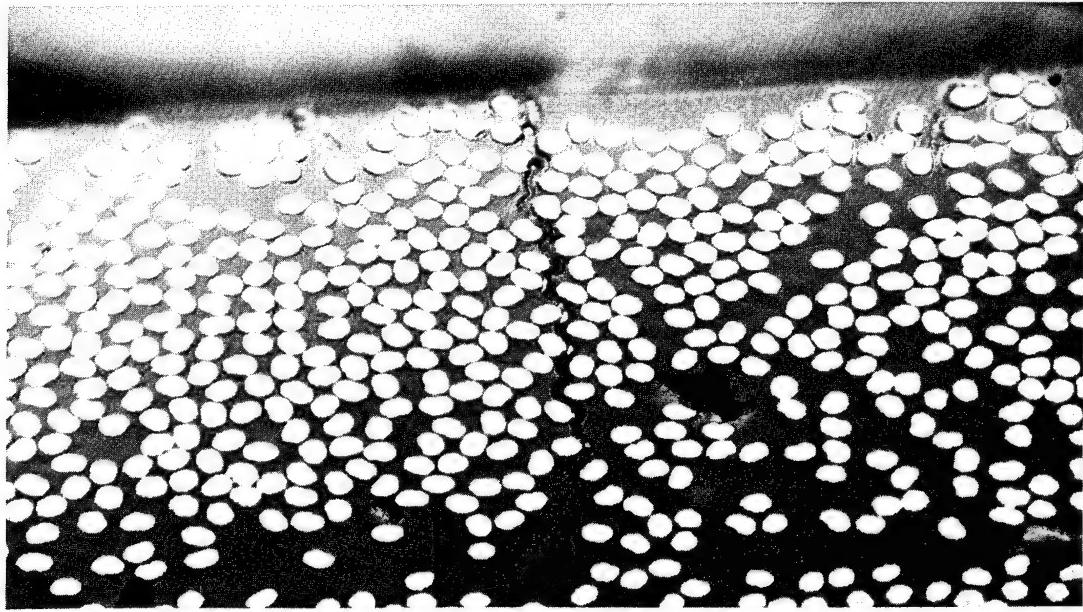
(a) Plate D2834, 100X, $(45/-45/0/90)_s$ T300/5209, Spec 12-8, exposed 70°C/95% RH,
-54°C to 93°C/100 cycles.

(b) Plate D2832, 500X, T300/5209, Spec 12-6, exposed 70°C/95% RH,
-54°C to 70°C/100 cycles.

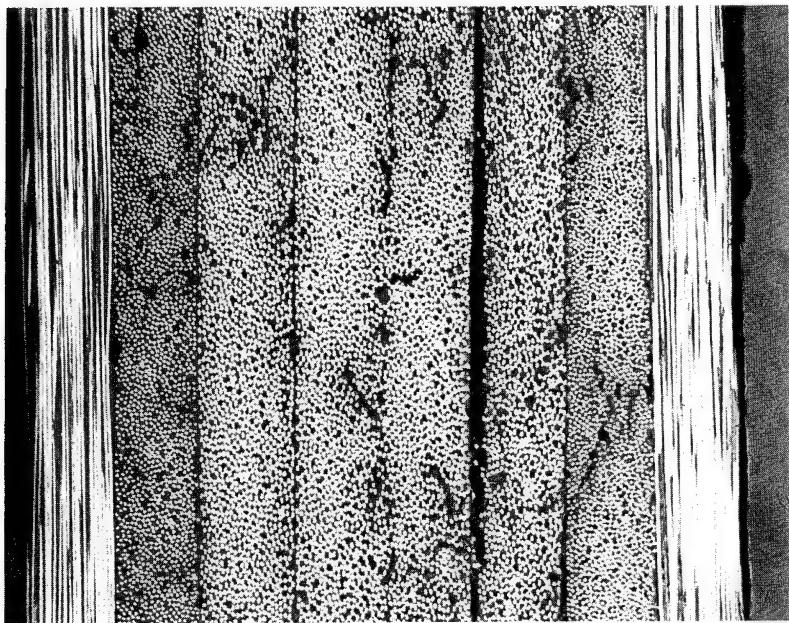
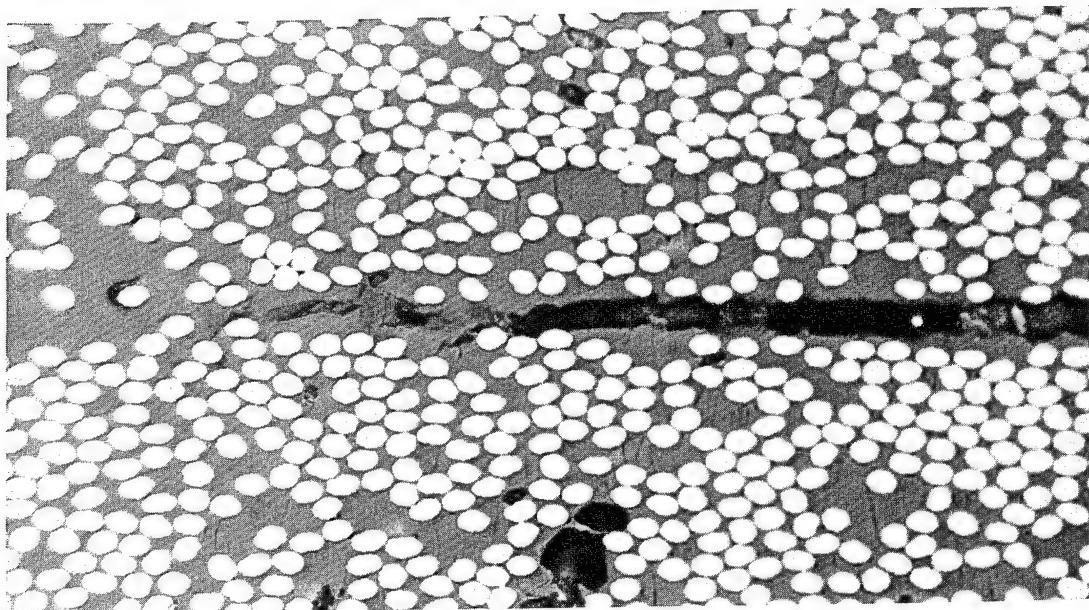
Figure 33.

(a) Plate D2837, 100X, T300/5209, Spec 13-2, exposed 70°C/95% RH,
-53°C to 70°C/100 cycles.

(b) Plate D2838, 500X, Spec 13-2.

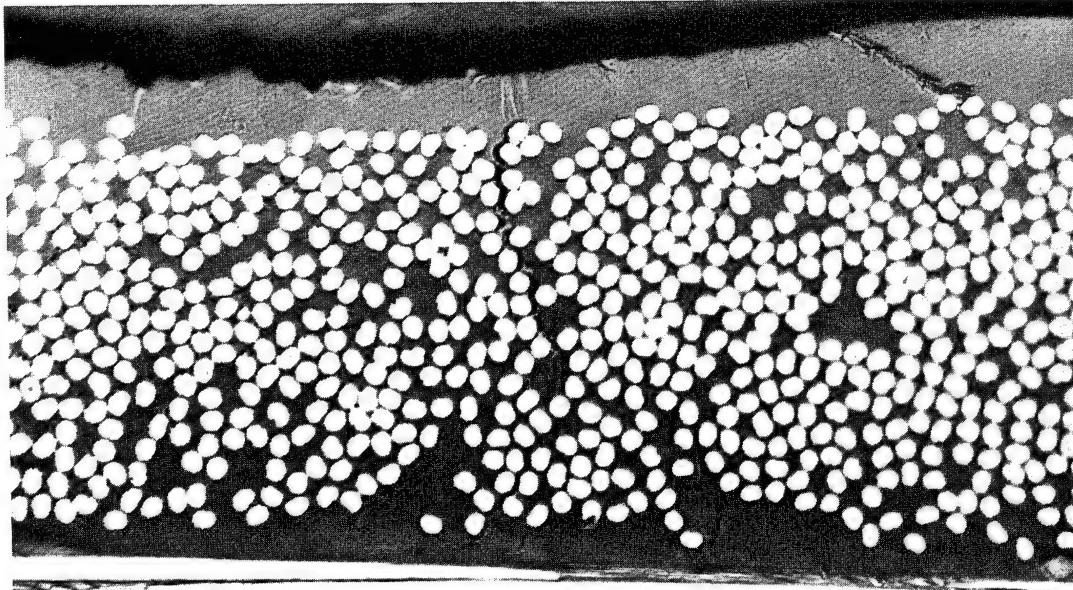
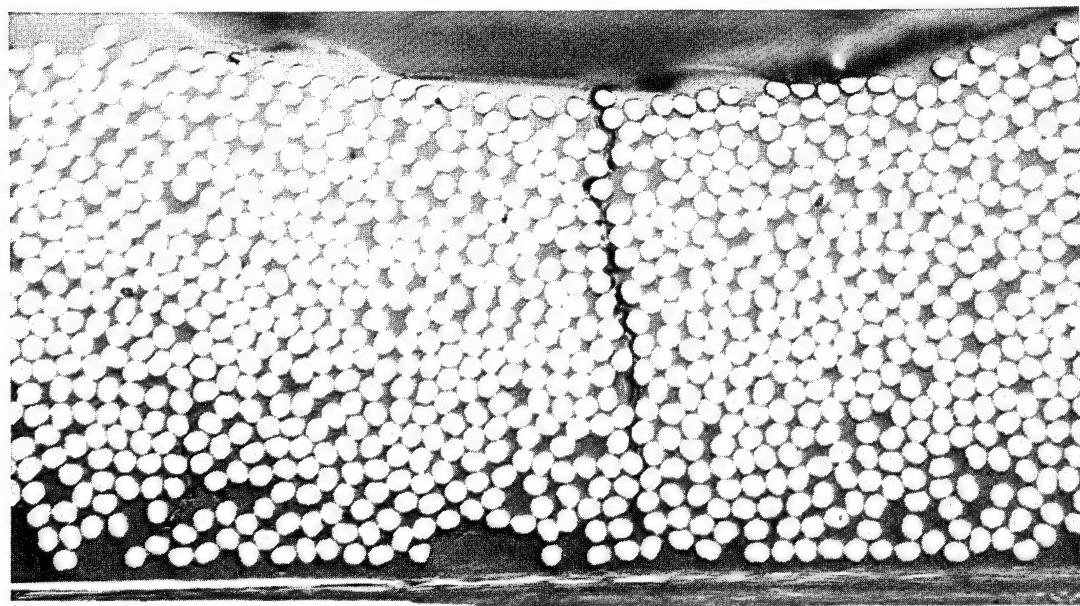
Figure 34.

(a) Plate 2836, 500X, $(90/0/\pm 45)_S$ T300/5209, Spec 15-8, exposed $70^\circ\text{C}/95\%$ RH,
 -54°C to $70^\circ\text{C}/100$ cycles.

(b) Plate D2840, 500X, T300/5209, Spec 15-4, exposed $70^\circ\text{C}/95\%$ RH,
 -54°C to $93^\circ\text{C}/100$ cycles.

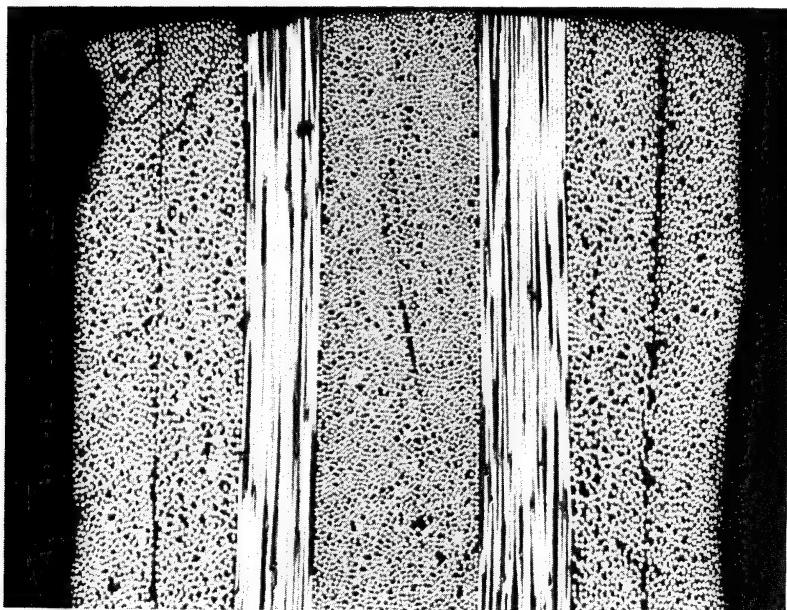
Figures 35 and 36 show evidence for free edge delamination of T300/5208 (+45, 0, 90)_s laminates after 100 cycles between -54°C and 93°C. The delamination is found primarily within or between the outer 45° plies and extends into the laminate a distance of 1 to 3 ply thicknesses. The edge cracking is just as prominent in dry specimens as those exposed to moisture. Furthermore, some delamination was observed at the opposite end of the specimen section which had been sliced by the diamond saw prior to metallographic polishing. It is suspected that the delamination observed here is caused by a combination of high thermally induced free edge stresses, as discussed in the next chapter, and some degree of stressing induced by

(a) Plate D2807, 100X, $(+45/0/90)_s$ T300/5208, Spec 27-4, dry, -54°C to $93^{\circ}\text{C}/100$ cycles.

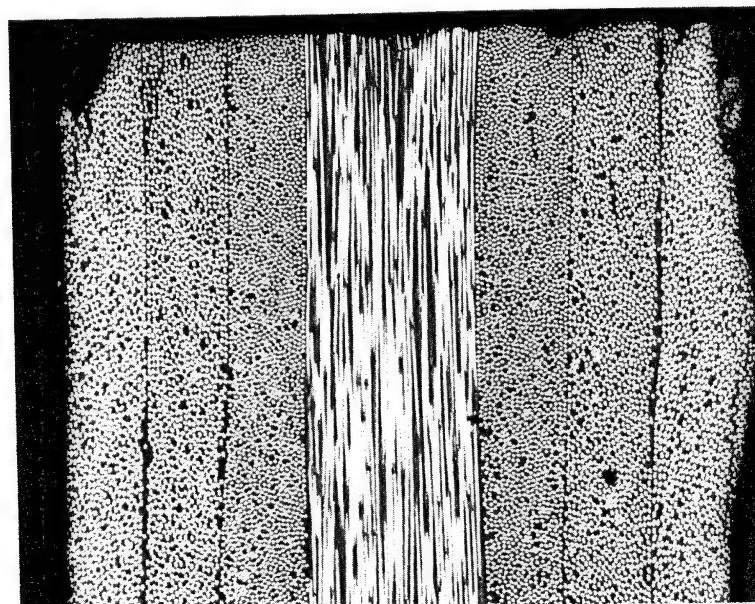
(a) Plate D2810, 100X, T300/5208, Spec 27-8, exposed 70°C/95% RH,
-54°C to 93°C/100 cycles.

(b) Plate D2811, 100X, Spec 27-8, Section at 90° to (a).
Figure 36.

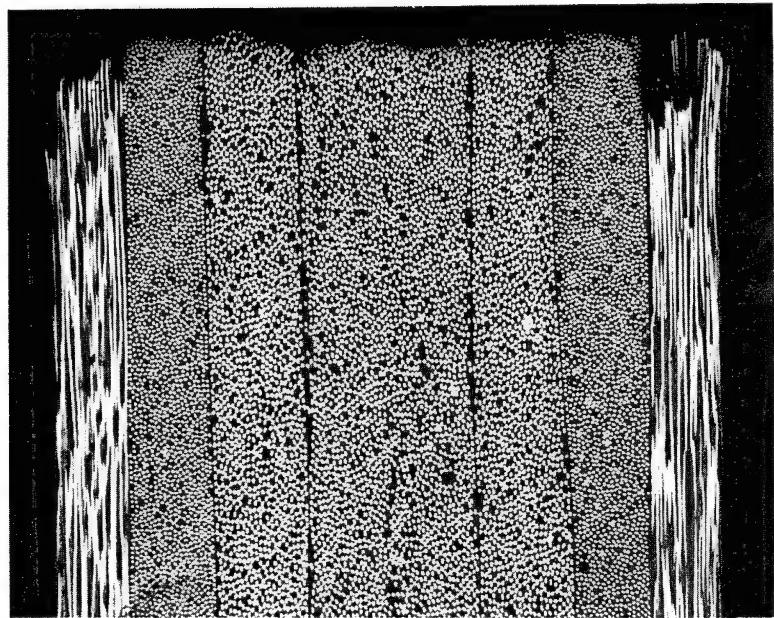
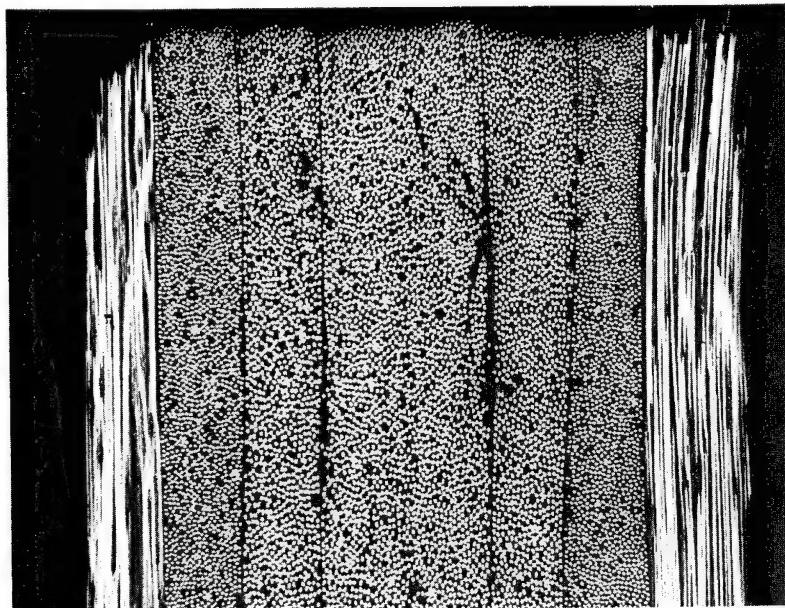
Figure 37.

(a) Plate D2817, 100X, $(90/0/45/-45)_s$ T300/5208, Spec 30-2, dry,
 -54°C to $70^{\circ}\text{C}/100$ cycles.

(b) Plate D2843, 100X, T300/5208, Spec 30-8, exposed to $70^{\circ}\text{C}/95\%$ RH,
 -54°C to $93^{\circ}\text{C}/100$ cycles.

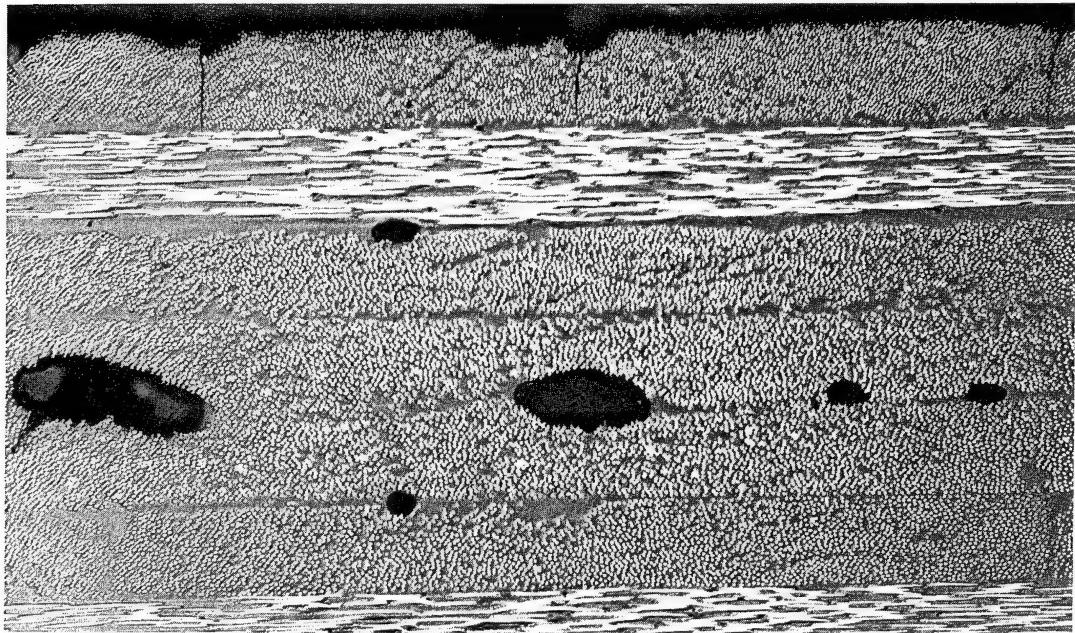
Figure 38 shows the only transverse cracking observed in the T300/5208 series. These specimens were taken from the panel fabricated at low pressure to develop large voids shown in Figure 38a. As in T300/5209, the rounded voids do not act as crack initiation sites during hygrothermal cycling. The transverse cracks appear to initiate at surface irregularities and extend only through the surface ply. At higher magnification in Figure 38b, there is evidence of fiber splitting and less evidence for the smooth matrix-fiber interface debonding typical of the T300/5209 system. Observations of transverse cracks in the thicker (0.14 cm) "voidy" T300/5208 laminate, but not in the thinner (0.10 cm) standard processed T300/5208 laminates is perhaps similar to observations by Hedrick and Whiteside [20] that thin laminates or neat resin specimens showed little or no evidence of surface cracking after hygrothermal cycling, while thicker laminates exposed to identical conditions exhibited surface cracks.

(a) Plate D2843, 80X, $(90/0/\pm 45)_S$ T300/5208, Spec 28-4, exposed to $70^\circ\text{C}/95\% \text{ RH}$, -54°C to $93^\circ\text{C}/100$ cycles.
